*Case Study*  
**Copper Pipe Corrosion**

*December 17, 2004*

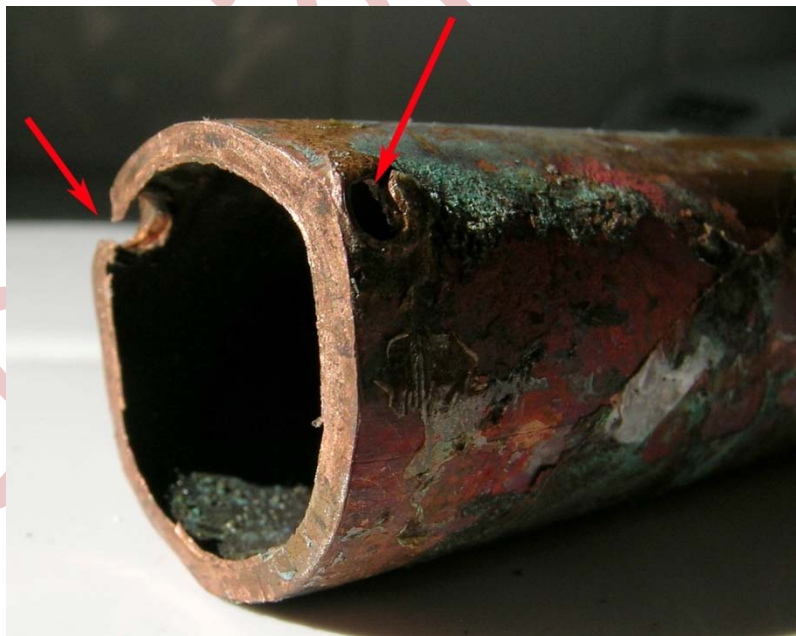
A 3/4 inch copper pipe was submitted for examination. The pipe had two holes representing the entry and exit point of a galvanized wood screw (Figure 1). The soft copper formed a seal around the screw preventing water from leaking initially. The deformation can be observed in Figure 2 and illustrates how the screw was able to penetrate and seal the pipe. No escaped water was detected or heard during the final inspection.

Figure 1. As-received copper pipe. Red arrows represent entry and exit point of wood screw.

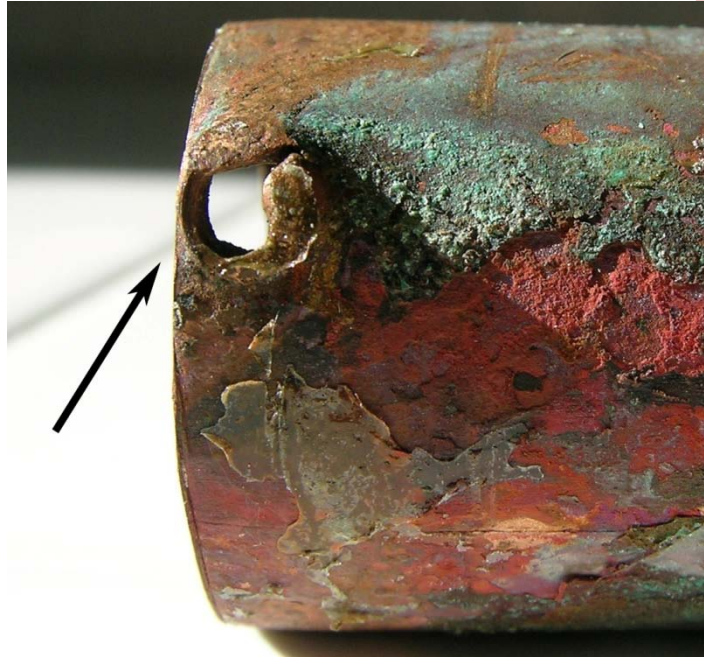
The wood screw gradually corroded away as the contact between copper and steel created a galvanic cell and the steel was exposed to oxygenated water. As the screw corroded away the seal it created lost integrity allowing water to escape at an increasing rate. Eventually the water was “spraying” out and could be heard behind the wall during a visit by the owners. The area damaged was behind the wall and inaccessible. To repair the pipe the cabinetry needed to be removed as well as significant water damaged material. Figure 3 illustrates the condition of the screw upon removal from the pipe. Its condition represents 14 months from installation to removal. The corrosion products consist of iron oxide (red) and zinc oxide (white).

Figure 2. Copper pipe illustrating hole created by wood screw. Note shape of hole reflects deformation created by wood screw penetrating wall of pipe.

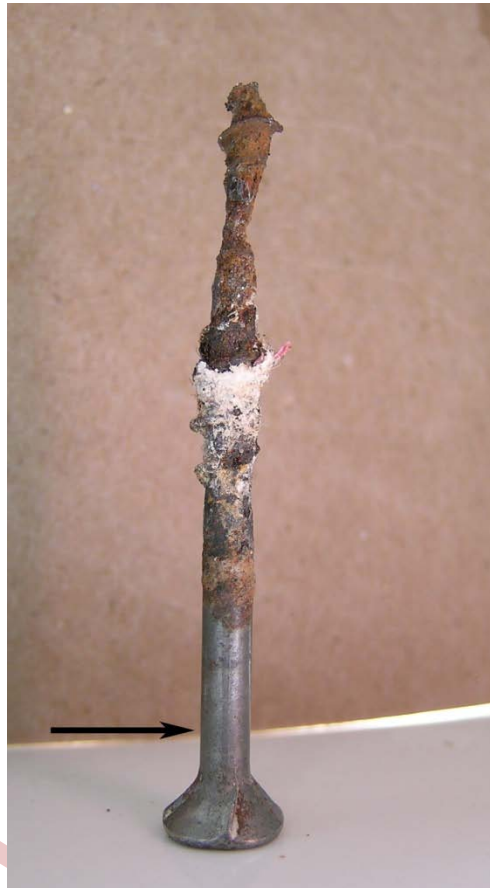
of damaged the pipe while installing cabinet lights. After reviewing the details it became very clear that the cabinet installer was responsible for breaching the water pipe with a wood screw due to its location and the degree to which the corrosion had advanced. (The owner discovered the leak only weeks after installing cabinet lights).

Figure 3. Cabinet screw as-received. Note the base still retains the zinc coating while most of the material was corroded away due to exposure to water and a more noble copper.
